**DEPARTMENT OF TRANSPORTATION****DIVISION OF ENGINEERING SERVICES**

Contract #: 04-0120F4Cty: SF/Ala Rte: 80 PM: 13.2/13.9File #: 69.28**WELDING INSPECTION REPORT****Resident Engineer:** Siegenthaler, Peter**Address:** 333 Burma Road**City:** Oakland, CA 94607**Report No:** WIR-017441**Date Inspected:** 24-Sep-2010**Project Name:** SAS Superstructure**OSM Arrival Time:** 1900**Prime Contractor:** American Bridge/Fluor Enterprises, a JV**OSM Departure Time:** 700**Contractor:** Zhenhua Port Machinery Company, Ltd (ZPMC), Changxing Island **Location:** Shanghai, China**CWI Name:** See below**CWI Present:** Yes No**Inspected CWI report:** Yes No N/A**Rod Oven in Use:** Yes No N/A**Electrode to specification:** Yes No N/A**Weld Procedures Followed:** Yes No N/A**Qualified Welders:** Yes No N/A**Verified Joint Fit-up:** Yes No N/A**Approved Drawings:** Yes No N/A**Approved WPS:** Yes No N/A**Delayed / Cancelled:** Yes No N/A**Bridge No:** 34-0006**Component:** Tower and OBG Components**Summary of Items Observed:**

**Bay 11**

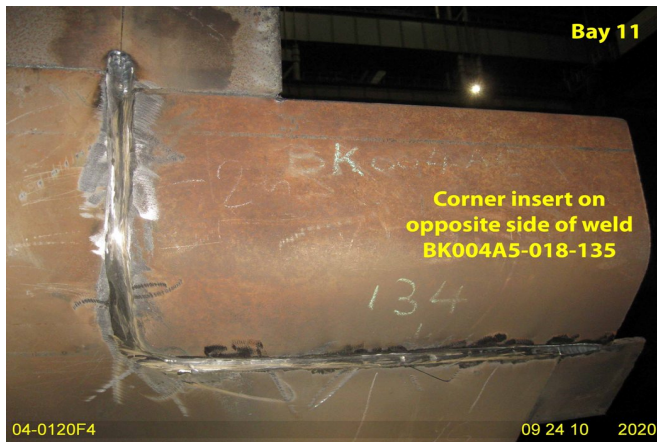
FCAW welding of weld joint BK004A1-021-005 located on PCMK BK004A1-021, side plate to bike path deck. Welder was identified as 053316. QC was identified as ZPMC CWI Xu Le Feng (QC1). Assisting QC1 at this location and appearing to be monitoring the welding and recording data was ZPMC QC Zhao Mao Mao (QCA1), who was not a CWI. Welding variables recorded by QCA1 appeared to comply with WPS-B-T-2232-TC-U4c-F. SMAW welding of weld joint BK004A5-018-135 located on PCMK BK004A5-018, corner insert to side plate. Welder was identified as 040723. QC was identified as QC1. Assisting QC1 at this location and appearing to be monitoring the welding and recording data was QCA1, who was not a CWI. Welding variables recorded by QCA1 appeared to comply with WPS-B-P-2212-B-U2. See photo below.

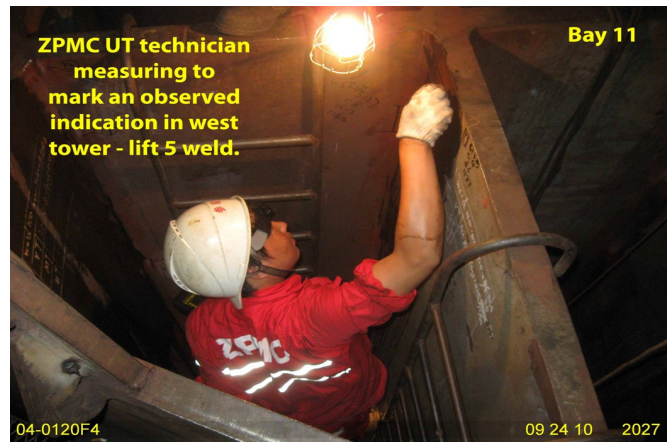
ZPMC personnel performing ultrasonic testing (UT) on various interior connection plate weld joints on west tower, lift 5. See photo below.
